Study of failure of gears and analysis through SEM of Fracture surface

¹Gowhar qudus, Research scholar, ²Er. Rahul

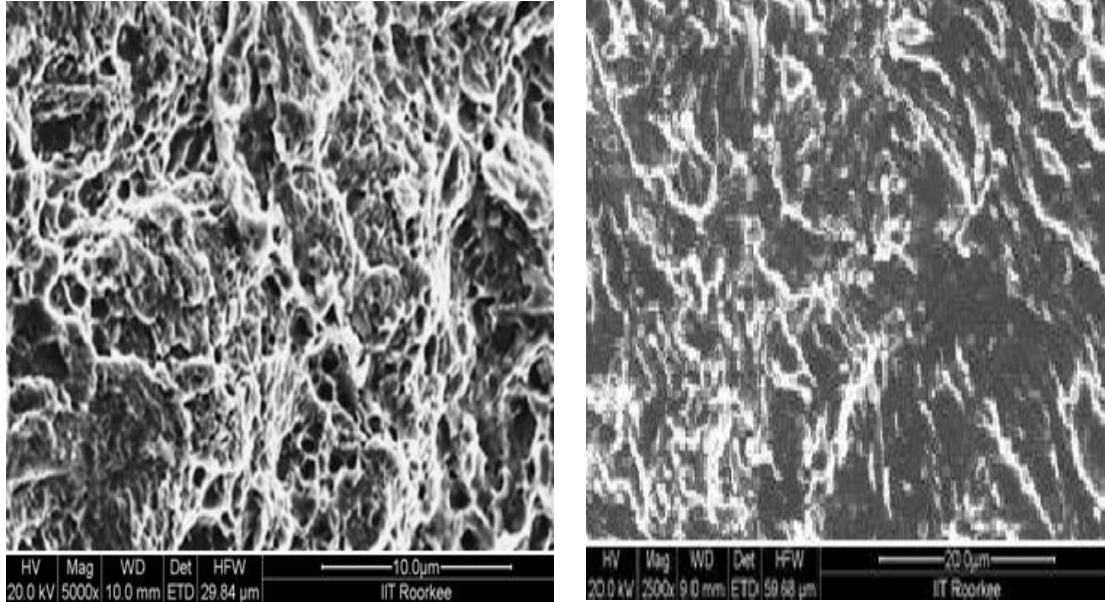
For Sample 1

Fracture surface study for all the samples was done under SEM. A micrograph surface reveals dimple marks in Fig.4.27 (a). Moreover, river-like pattern which is a typical characteristics of cyclic brittle failure mode is visible in Fig.4.27 (a) and 4.28(a). However, striations, which is a typical characteristic of cyclic failure mode is embodied in the fracture surface.

Fig Fractograph of etched sample 1 (a) at 5000X (b) at 2500X

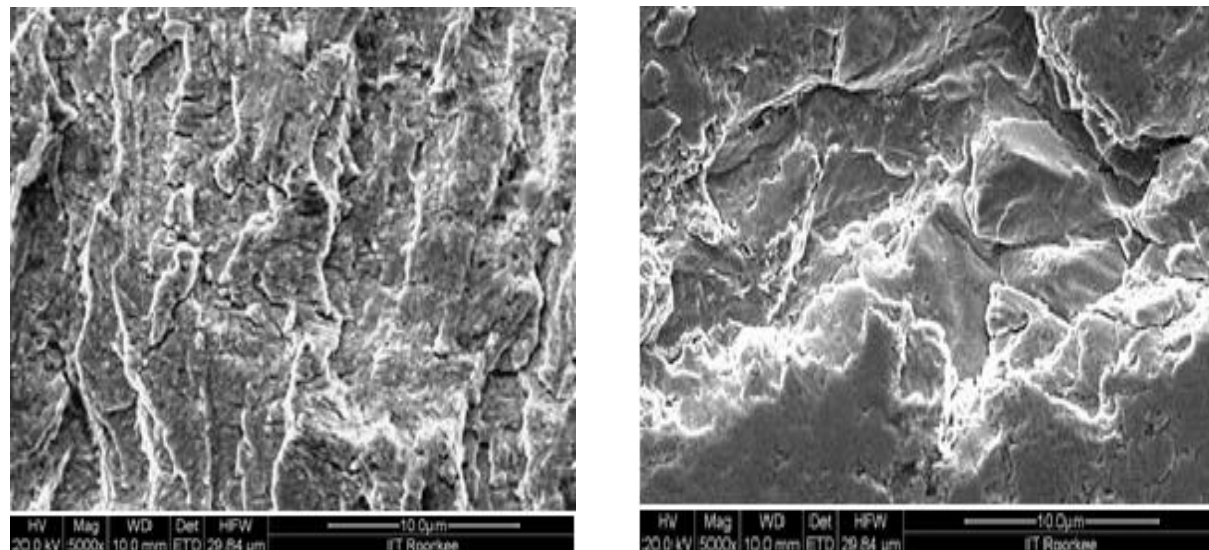
For Sample 2

Fig Fractograph of etched sample 2 (a) at 5000X (b) at 2500X

The carbide precipitation along the grain boundary has lead to the failure of this material.
Fig. 4.28(b) shows the typical micrograph containing carbides particles sample 2.

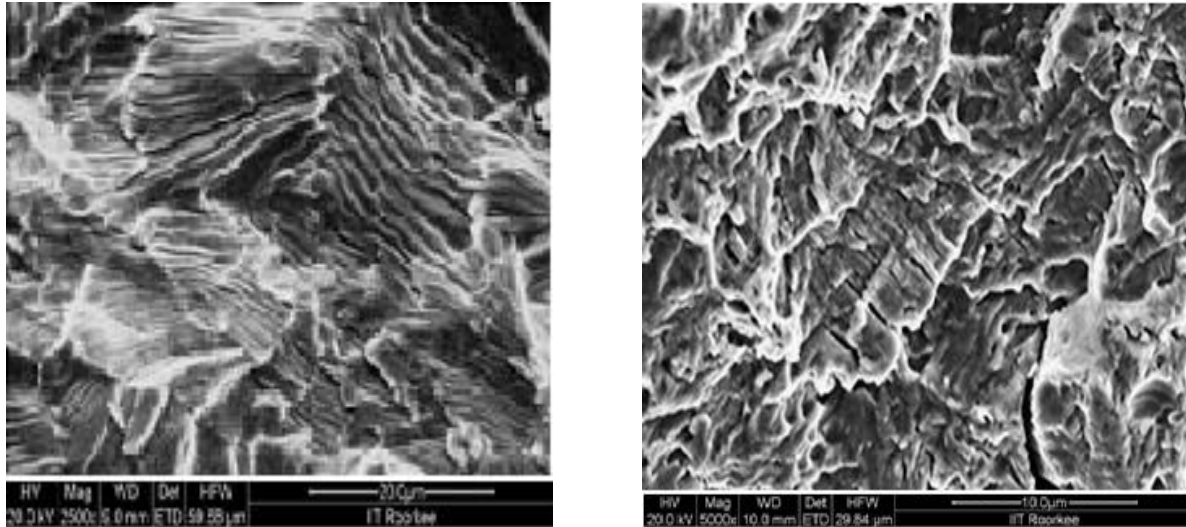
For Sample 3

Fig Fractograph of etched sample 3 (a) at 2500X (b) 5000X

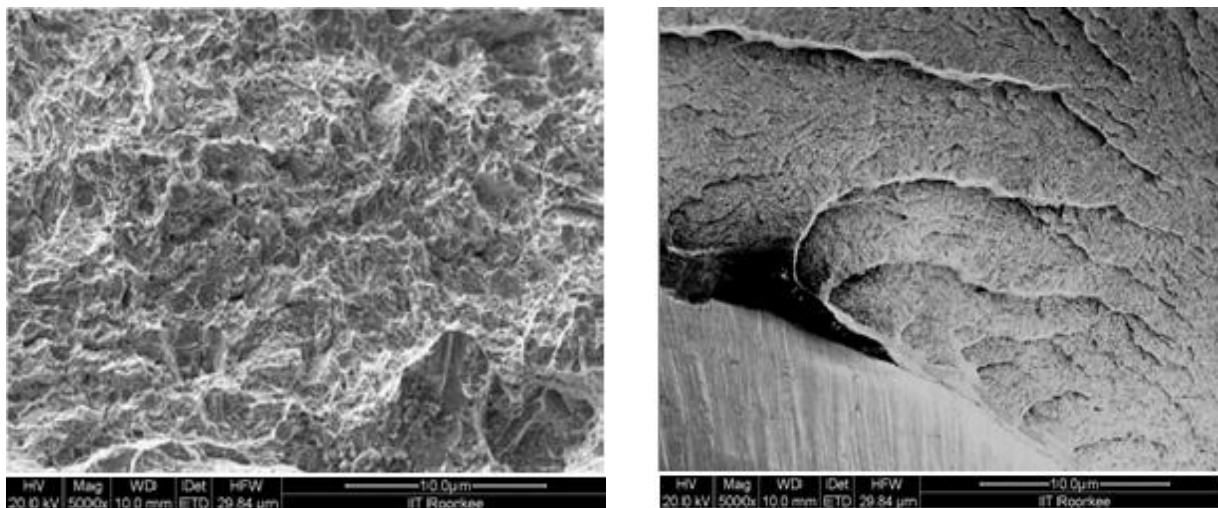
For sample 4

In case of sample 4, fatigue failure mode can be observed. Since the fatigue striation are oriented in same direction. The crack has propagated along grain boundaries. Carbides are visible in Fig

Fig Fractograph of etched sample 4 (a) at 2500X (b) 5000X

The fatigue failure is not observed to be dominant cause of fracture as depicted by Fig. of sample 4. The fracture surface exhibits typical characteristics where ductile and brittle both characters are present. However in certain area river like pattern is also visible.

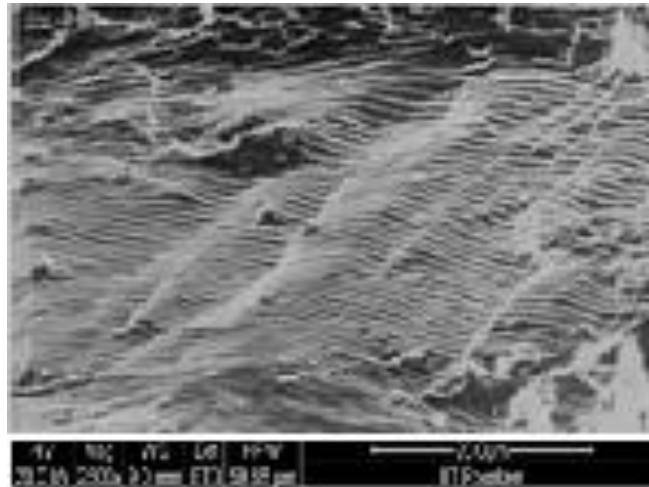
For Sample 5

Fig Fractograph of etched sample 5 at 2500X

Fig. of sample 5 exhibit a cyclic failure as evident from presence of striations. The fracture surface was characterized to be a brittle type failure with signs of fatigue striations.

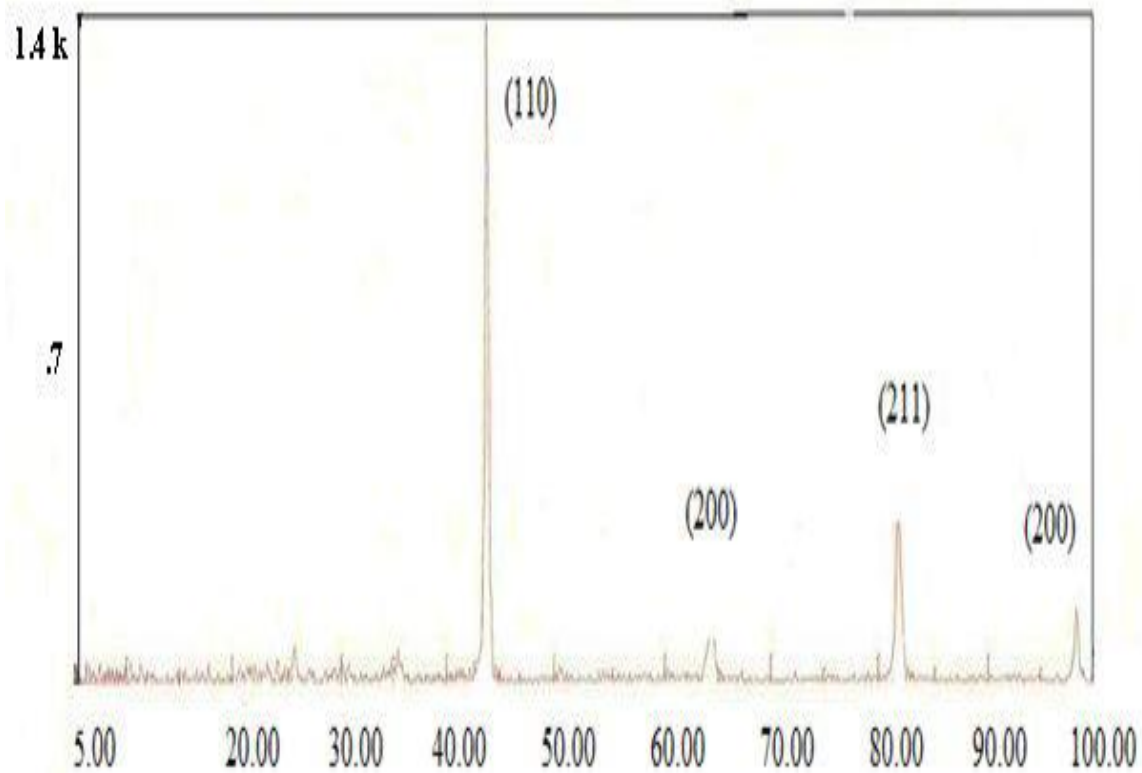
Fig. XRD pattern of 1st gear specimen

From x-ray diffractogram pattern, it was observed that highest intensity of peaks belonging to pure iron phase (JCPDF card no. 60696) is present. The planes of diffraction are indicated above their respective peaks in the graph as shown in Figs. . Some other peaks having lower intensity are also found but are not clearly visible. So we can't compare them with any data file because these peaks are mostly due to impurities or mixture of phases. X ray diffractogram shows only some variations in peak intensities in first and second gear specimen. However only pure iron phase have been detected in both of them.

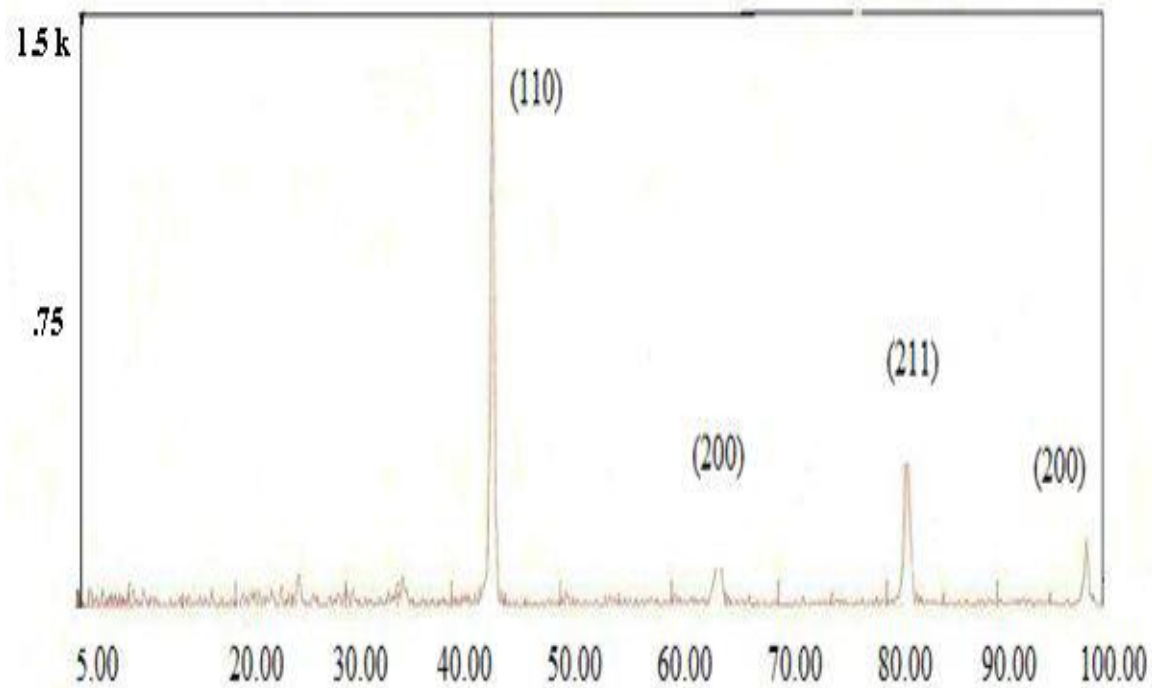
Fig. XRD pattern of 2nd gear specimen
