# Study of pavement failure, their possible cause and Factors affecting the

# performance of a pavement.

<sup>1</sup>Shankar Raj Lohani, <sup>2</sup>Ajit Singh

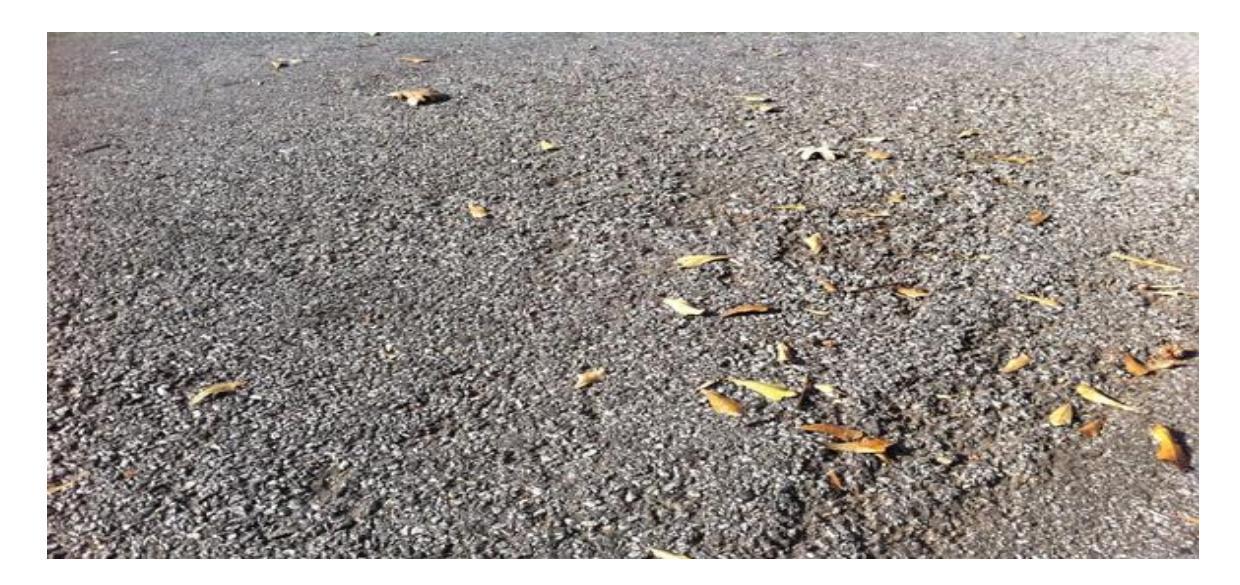
The progressive disintegration of pavement layer from the surface download as a result of the dislodgement of aggregate particles:

### **Raveling in Pavement**

The failure can be due to loose debris on the pavement, roughness, water collecting in the raveled locations resulting in vehicle hydro planning, loss of skid resistance.

Possible cause: Loss of bond between aggregate particles and the asphalt binder as a result of

A dust coating on the aggregate particle that forces the asphalt binder to bond with the dust rather than the aggregate

Aggregate segregation if the fine particles are missing from the aggregate matrix then the asphalt binder is only able to bind the remaining coarse particles at their relatively few contact points. Inadequate compaction during construction. High density is required to develop sufficient cohesion within the Hot Mix Asphalt

**Repairs:** A raveled pavement should be investigated to determine the root cause of failure. Repair strategies generally fall into one of two categories:

- Small localized areas of raveling. Remove the revealed pavement and patch
- Large raveled areas indicative of general Hot Mix Asphalt failure. Remove the damaged pavement and overlay.

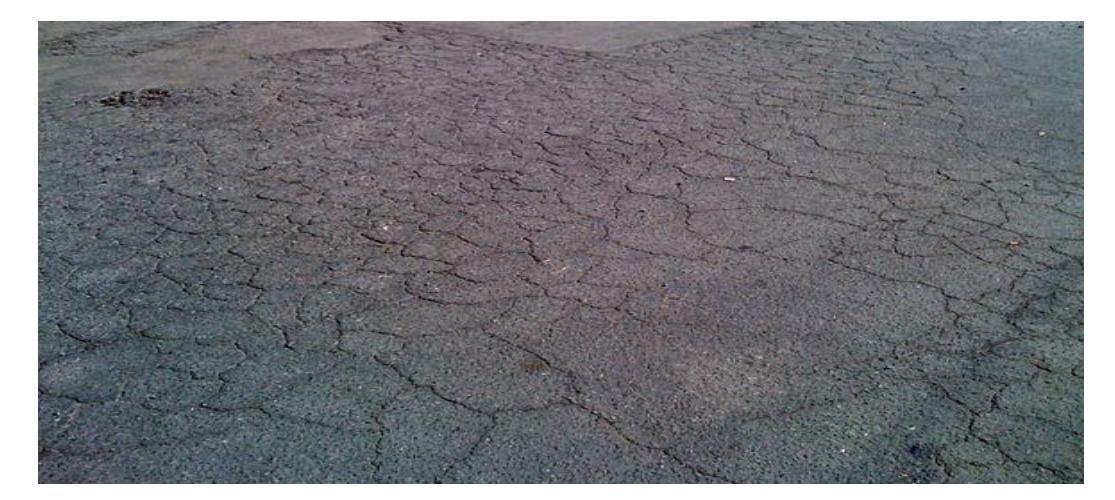
Cracks in pavement surface due to structural failure which starts as longitudinal cracks in wheel path and spread as alligator cracking.

#### **Alligator Cracking in Pavement**

The failure can be due to weakness in the surface, base or subgrade.

#### **Possible cause:**

- Thin surface and base course layer
- Inadequate or poor subgrade
- Poor drainage or combination of three

**Repairs:** As a structural failure is taking in place the only possible solutions to alligator cracking is to perform a full depth patch.

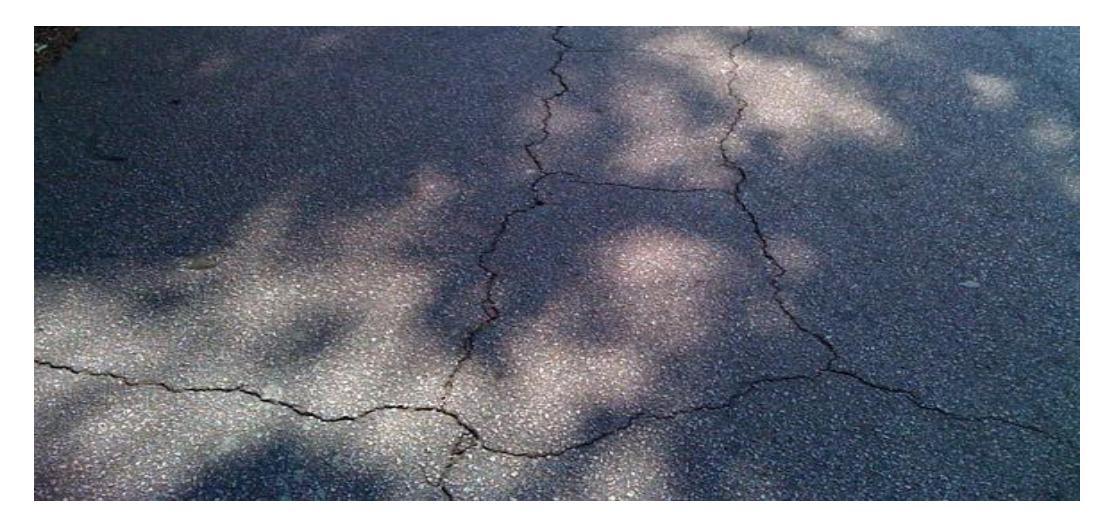
Block cracking look like interconnected rectangles (roughly). Block cracking is not loadassociated, but generally caused by shrinkage of the asphalt pavement. due to an inability of asphalt binder to expand and contract with temperature cycles.

**Block Cracking in Pavement**

**Possible cause**: Shrinkage of asphalt pavement due to an inability of asphalt binder to expand and contract with temperature cycles.

Mix was mixed and placed too dry, Fine aggregate mix with low penetration asphalt & absorptive aggregates, poor choice of asphalt binder in the mix design, or aging dried out asphalt.

**Repairs:** Less severe cracks measuring 10-15 mm or less can be sealed to prevent moisture from entering into the subgrade. More severe cracks should be fixed by removing the cracked pavement layer and replacing it with an overlay.

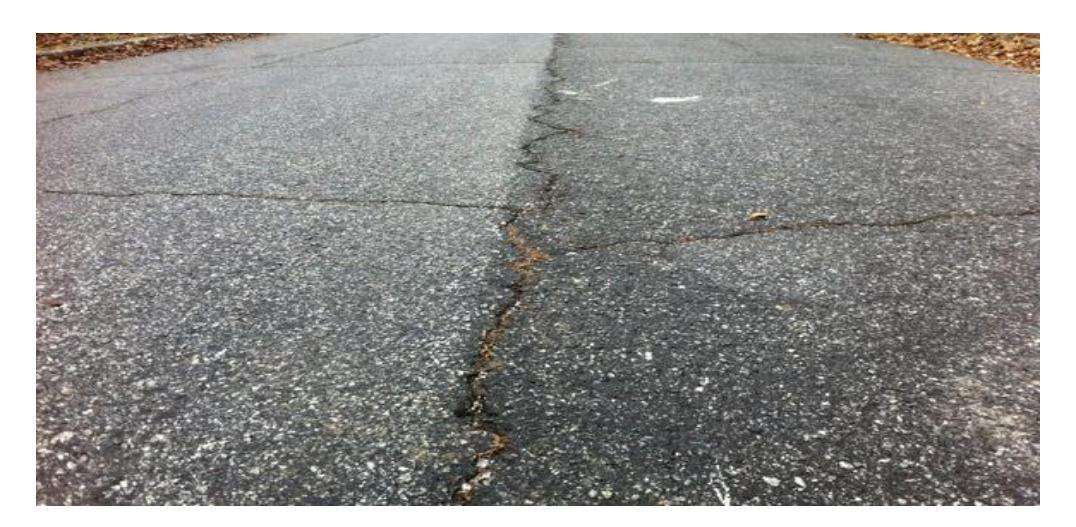
Longitudinal cracking are cracks that are parallel to the pavement centerline or laydown direction.

**Possible cause**: These can be result of fatigue, reflective cracking, and or poor construction joints. Joints are generally least dense areas of a pavement.

### Longitudinal (Linear) Cracking in Pavement

**Repairs:** Less severe cracks measuring 10-15 mm or less can be sealed to prevent moisture from entering into the subgrade. More severe cracks should be fixed by removing the cracked pavement layer and replacing it with an overlay.

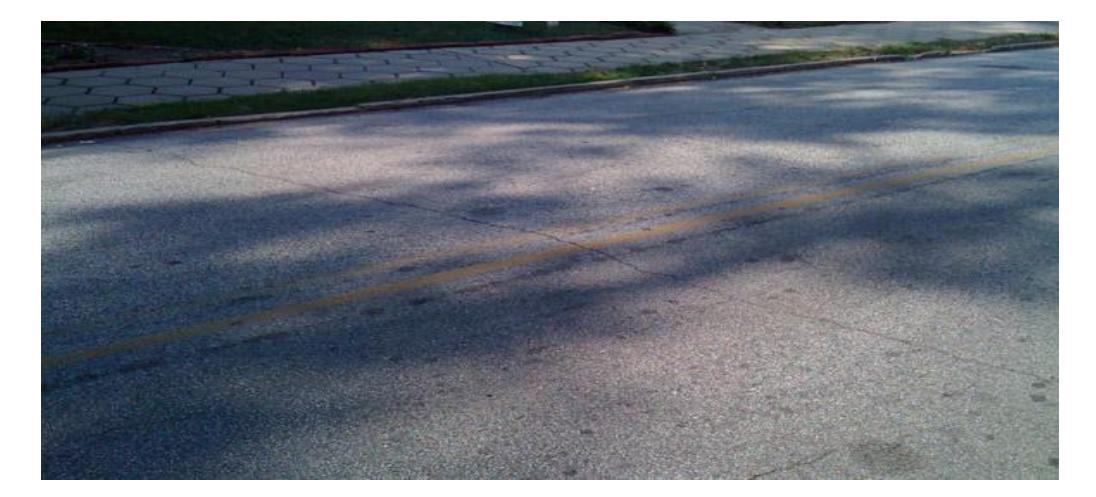
Transverse cracks are single cracks perpendicular to the pavement's centerline or laydown direction.

**Possible cause**: Transverse cracks can be caused by reflective cracks from an underlying layer, daily temperature cycles and poor construction due to improper operation of the paver.

### **Transverse Cracking in Pavement**

**Repairs:** Less severe cracks measuring 10-15 mm or less can be sealed to prevent moisture from entering into the subgrade. More severe cracks should be fixed by removing the cracked pavement layer and replacing it with an overlay.

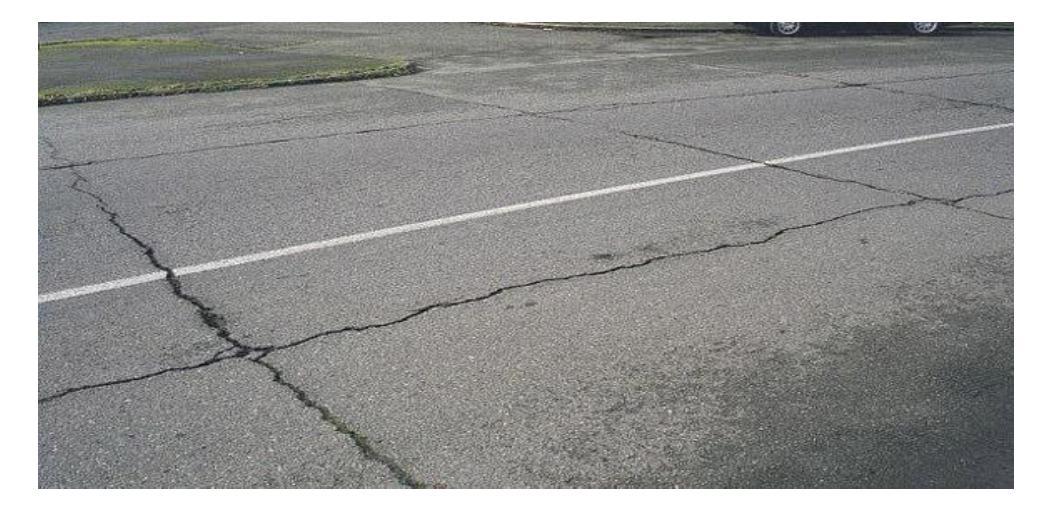
These are cracks in a flexible pavement overlay of a rigid pavement ( i.e. asphalt over concrete pavement). These types of cracks occur directly over the underlying rigid pavement joints. Joint reflection cracking does not include reflection cracks that occur away from an underlying joint or from any other type of base

Possible cause: Due to improper joint treatment during overlay

#### Joint Reflection Cracking in Pavement

**Repairs:** Less severe cracks measuring 10-15 mm or less can be sealed to prevent moisture from entering into the subgrade. More severe cracks should be fixed by removing the cracked pavement layer and replacing it with an overlay.

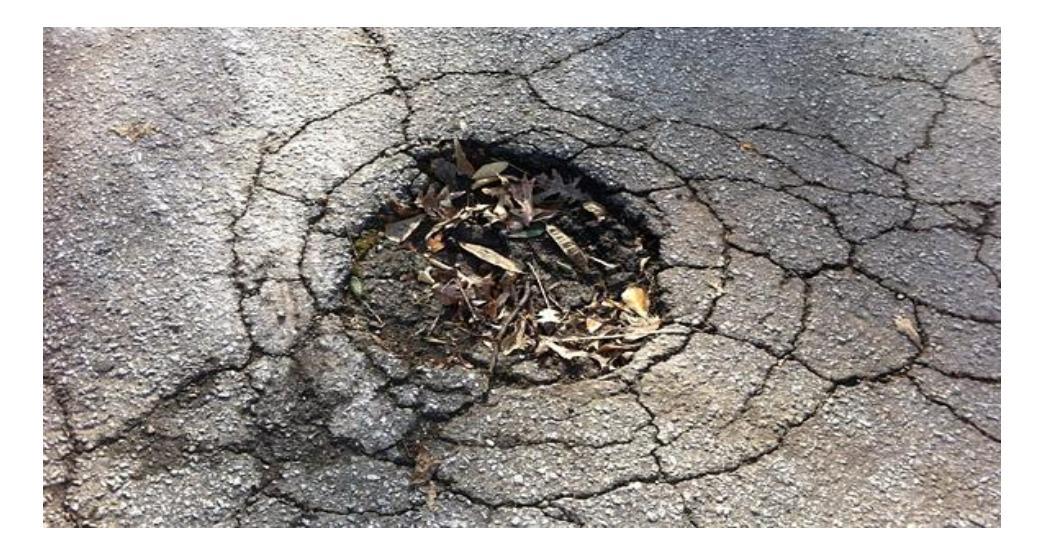
Pothole is very common pavement failure in flexible pavement. Small, bowl-shaped depressions in the pavement surface that penetrate all the way through the asphalt layer down to the base course. They generally have sharp edges and vertical sides near top of the hole.

**Possible cause**: Potholes are the result of moisture infiltration and usually the end result of untreated alligator cracking. As alligator cracking becomes severe, the interconnected cracks create small chunks of pavement, which can be dislodged as vehicles drive over them.

### Potholes

**Repairs:** Full depths patch replacement.

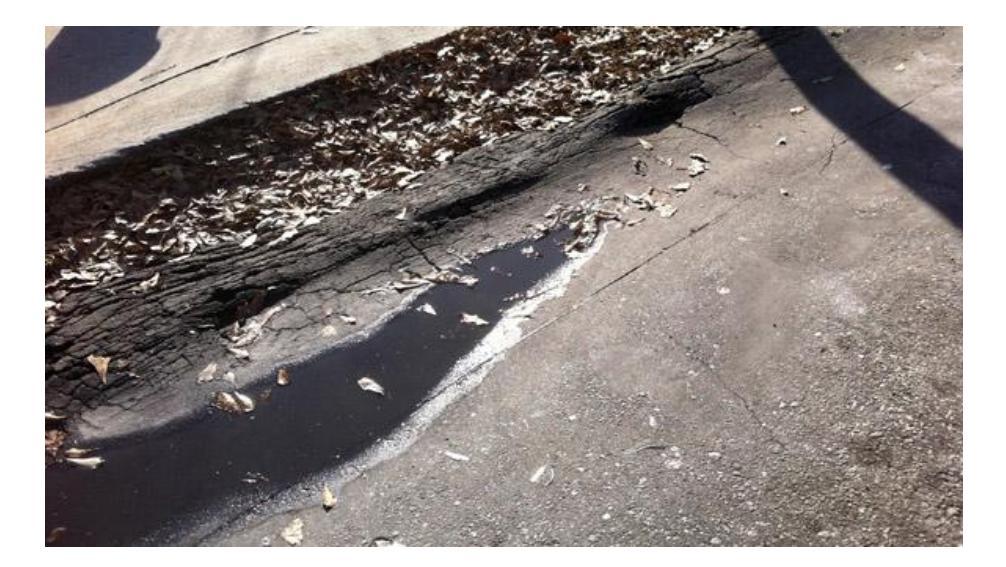
Ruts in asphalt pavements are channelized depressions in the wheel-tracks.

**Possible cause**: Rutting results from consolidation or lateral movement of any of the pavement layers or the subgrade under traffic. Rutting is caused due to insufficient pavement thickness, lack of compaction of the asphalt, stone or soil, weak asphalt mixes or moisture infiltration.

### Rutting

**Repairs:** If rutting is minor or if it has stabilized, the depressions can be filled and overlaid. If the deformations are severe, the rutted area should be removed and replaced with suitable material.
